A possible almshouse at Creag a'Phuirt, Loch Lomond, Argyll & Bute, Scotland

Data Structure Report
Report No 1
Project ID: CA001

Creag a'Phuirt, Loch Lomond, Argyll & Bute, Scotland

Data Structure Report

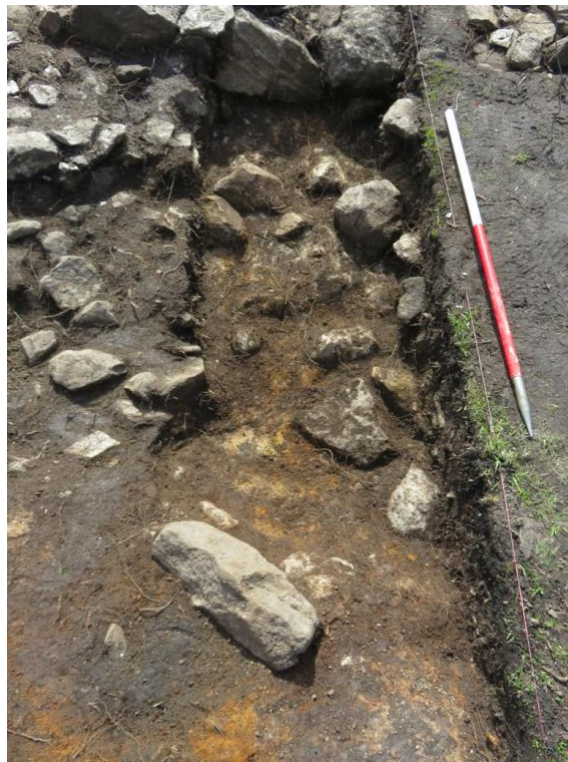
Illus. 10: Red/brown and orange silt (010) to the north of the structure

Outside the structure to the north, the subsoil formed a slight hollow within which there was a layer of mottled red/brown and orange silt (context 010) up to 0.12m deep (see Illus. 10). This layer abutted, but did not go beneath the wall (002). Layer (010) was sealed by angular stones within a soil matrix of compact dark brown peaty soil (005) and a layer of dark brown peaty soil with numerous roots (004).

The mottled silt (context 010) seen outside the structure and extending towards the north contained fragments of corroded circular metal tins, and probably represented the remains of numerous campfires. It contained ash, presumably derived from peat, but no visible charcoal. Layer (010) lay beneath the layer of tumble (005), suggesting that it could have been deposited before the structure was demolished.

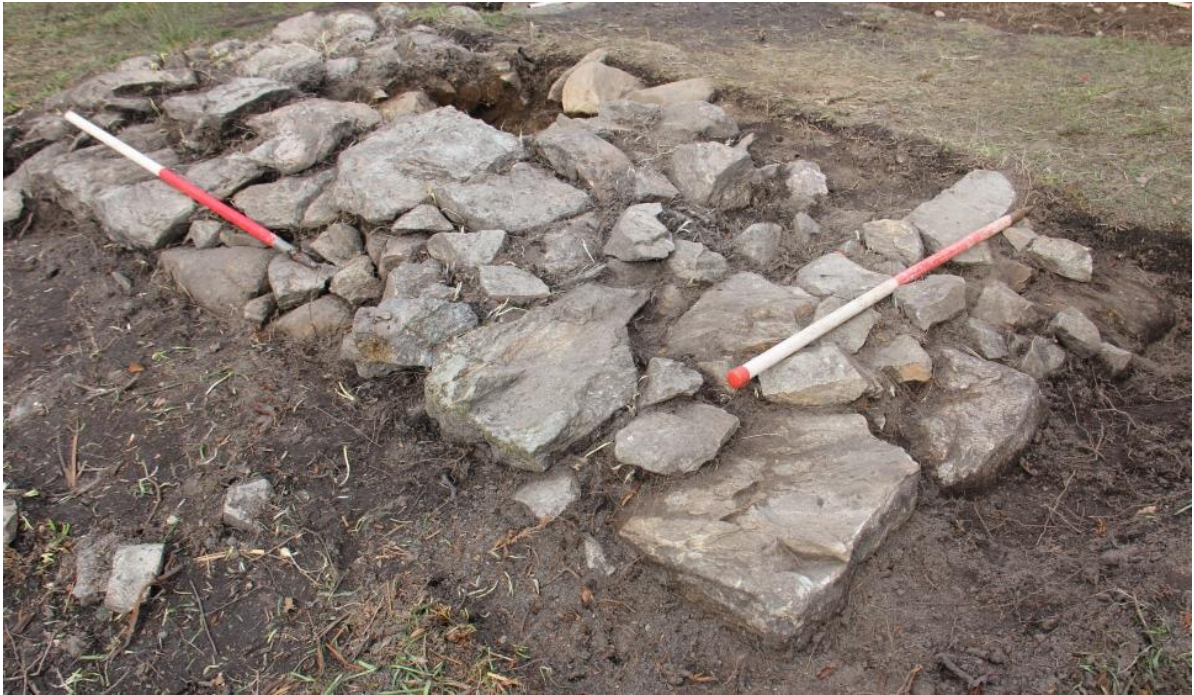
Illus. 12: Trench 2, west wall (002) and internal tumble (009) revealed

A small sondage, measuring 0.7m by 0.9m, was dug against the inside of the west wall (002). The subsoil here was seen at a depth of 0.3m below the surface (see Illus.12 & 13). The subsoil was covered with a layer of dark brown silty sand with occasional rounded pebbles and small fragments of charcoal (018), similar to layer (015). Above layer (018) was a layer of orange brown silty sand (013), which also contained occasional small rounded pebbles, which was in turn covered by a layer of loose yellow sand (012/017). Layer (012/017) was then sealed by a layer of angular stones within a peaty matrix (009), (see Illus. 12).

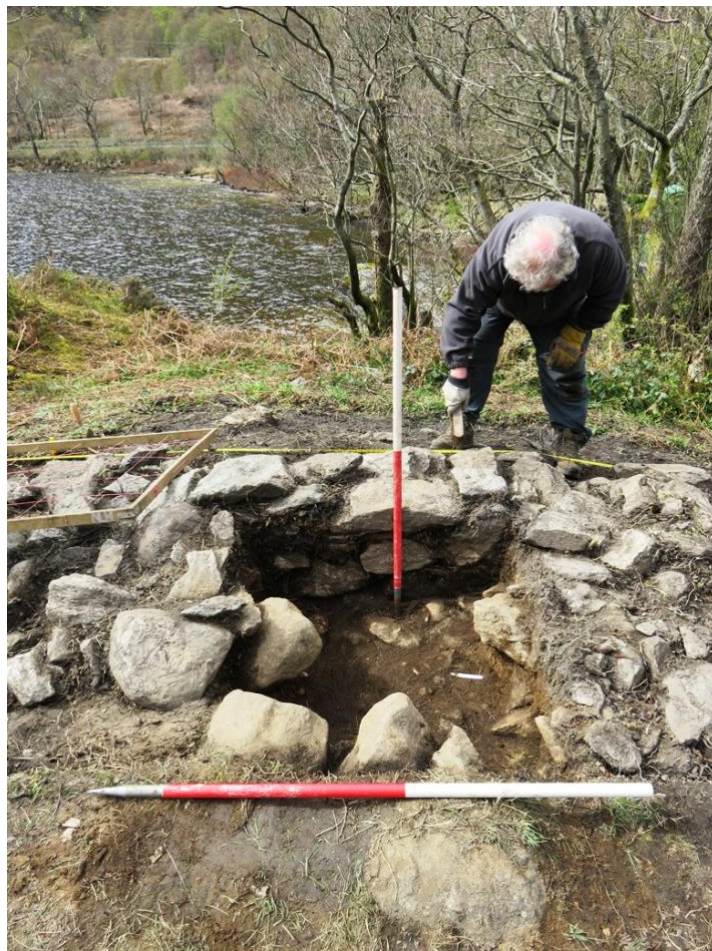
Illus. 13: Trench 2, sondage against the west wall

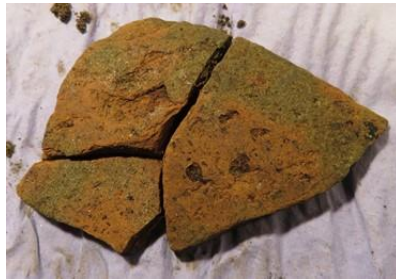
Illus. 22: Broken pot sherd from floor layer (015) (dated to the 17th century) (George Haggarty pers. comm.)

The floor layer (018) contained one sherd of clear, pre-industrial window glass (see Appendix 5, Glass Report by Helen Spencer and Illus. 21). The floor layer (015) contained a single sherd of pottery identified as 17th century in date (George Haggarty pers. comm.), (see Illus. 22), a small corroded nail, a corroded lump of metal, a roof-slate fragment and a fragment of possible burnt daub or brick (see Illus. 23 & 24).

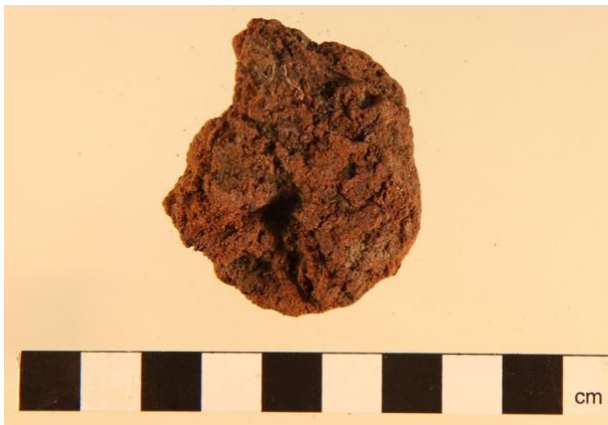
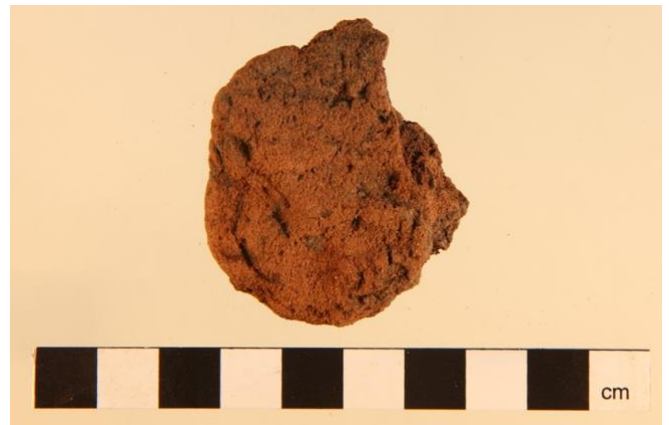
Illus. 23 and 24: Two sides of a piece of burnt daub or brick from context (018)

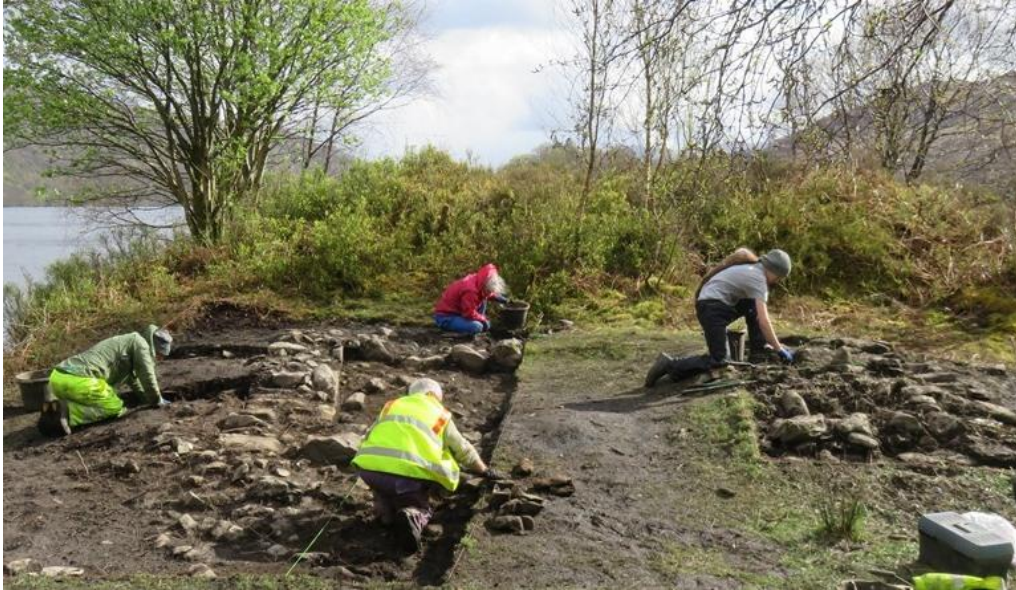
Illus. 25: View of the possible almshouse from the north with rising ground behind

The excavation revealed the foundations of a slightly trapezoidal-shaped, well-constructed, possibly two-storied structure. The construction, location and date suggest that these may have been the foundations of the reported almshouse (see Illus. 25).

The building was small, extending for 5.5m east-west and 3.9m north-south. The walls survived to a maximum height of 0.4m in the west end. They were drystone walls about 0.6m to 0.7m wide, built directly onto the subsoil. Although the floor plan of the building was slightly asymmetrical, it was well-constructed with substantial quarried stones used to face the walls, and smaller stones within the core. No entrance was identified within the surviving foundations. It is possible that an entrance may have been located in the south wall, which was not fully revealed, but this is unlikely, because it would have been awkward to access due to the rising ground behind (see Illus. 25).
